Cortland Enlarged City School District Building Condition Survey

School District Name: Cortland Enlarged City School District
Contingency %: 10%
Incidentals %: 20%

Introduction:

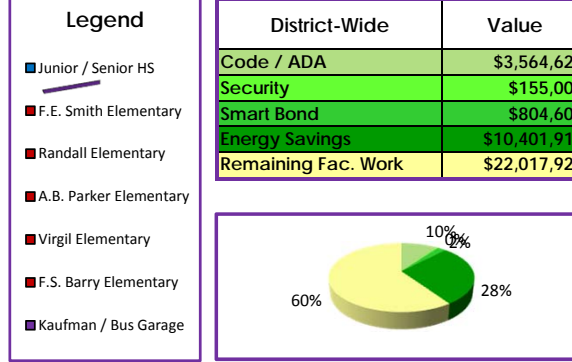
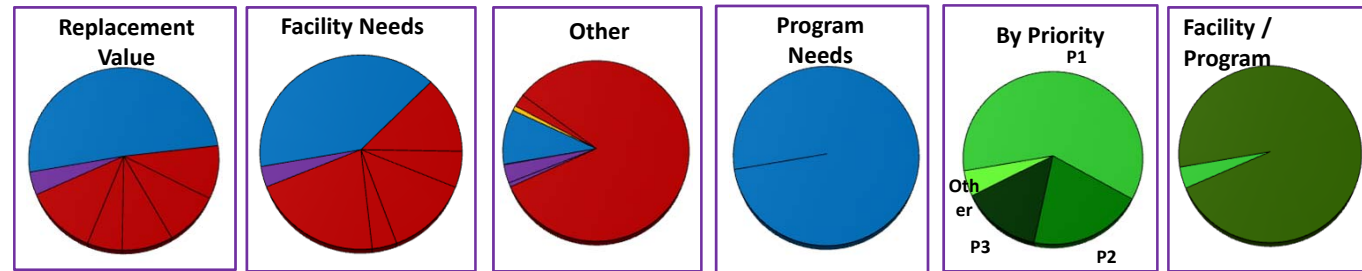
Facility	Replacement Value	Facility Needs	FCI*	Program Needs
Junior / Senior HS	\$60,947,550	\$14,865,200	24.4%	\$1,500,000
F.E. Smith Elementary	\$11,271,600	\$4,729,840	42.0%	\$0
Randall Elementary	\$11,096,000	\$2,222,290	20.0%	\$0
A.B. Parker Elementary	\$10,114,600	\$4,855,250	48.0%	\$0
Virgil Elementary	\$6,930,800	\$1,421,320	20.5%	\$0
F.S. Barry Elementary	\$14,484,800	\$7,582,288	52.3%	\$0
Kaufman / Bus Garage	\$4,875,000	\$1,267,875	26.0%	\$0
District-Wide:	\$119,720,350	\$36,944,063	30.9%	\$1,500,000

District-Wide	Value
Code / ADA	\$3,564,625
Security	\$155,000
Smart Bond	\$804,600
Energy Savings	\$10,401,910
Remaining Fac. Work	\$22,017,928

* FCI = Facility Condition Index
 ** Construction Cost w/o Escalation

Dashboard: The dashboard displays interactive charts and tables that analyze the facility and space / program needs. Information includes Facility Condition Index (FCI), which equals maintenance, repair and replacement deficiencies of the facility divided by the current replacement value of the facility.

Facility Condition Index (FCI): The FCI equals the Facility Needs divided by the Replacement Value.

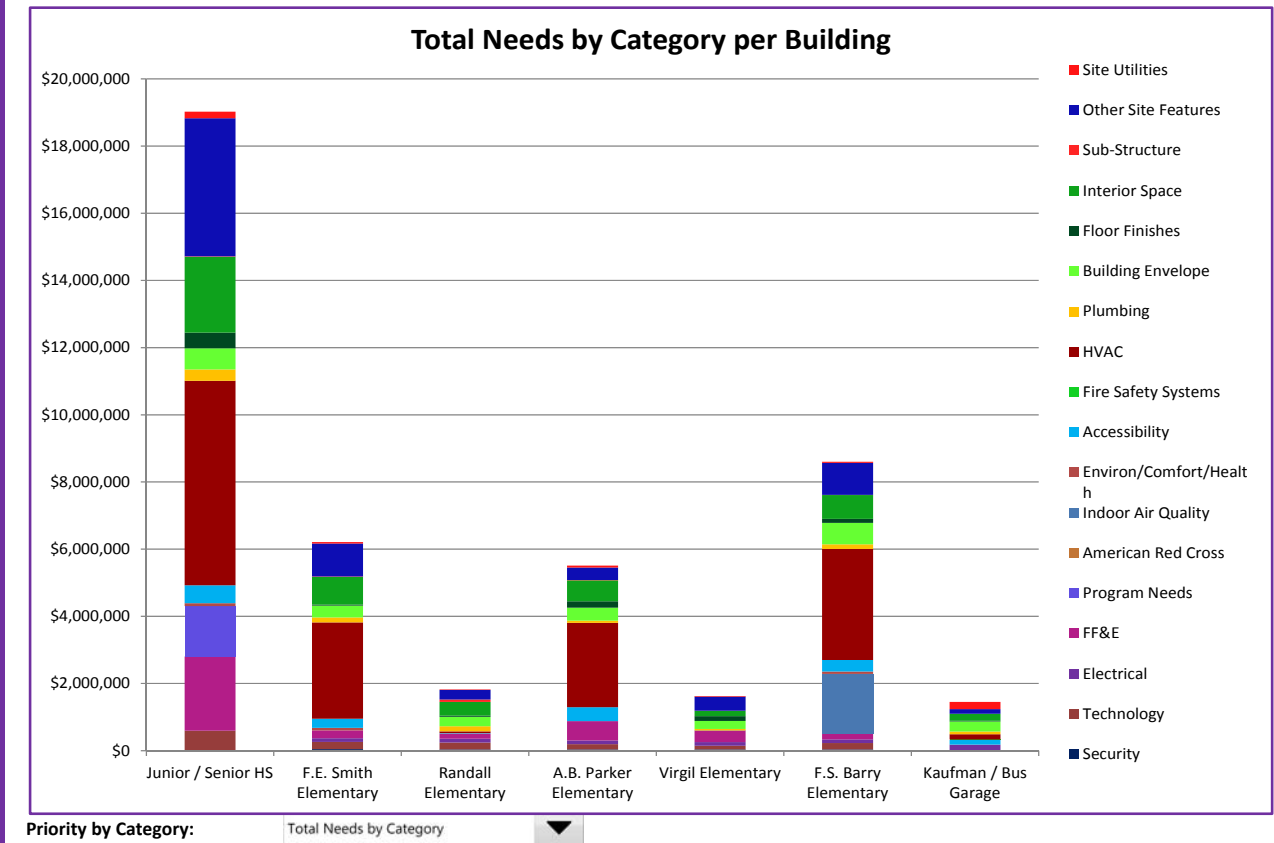
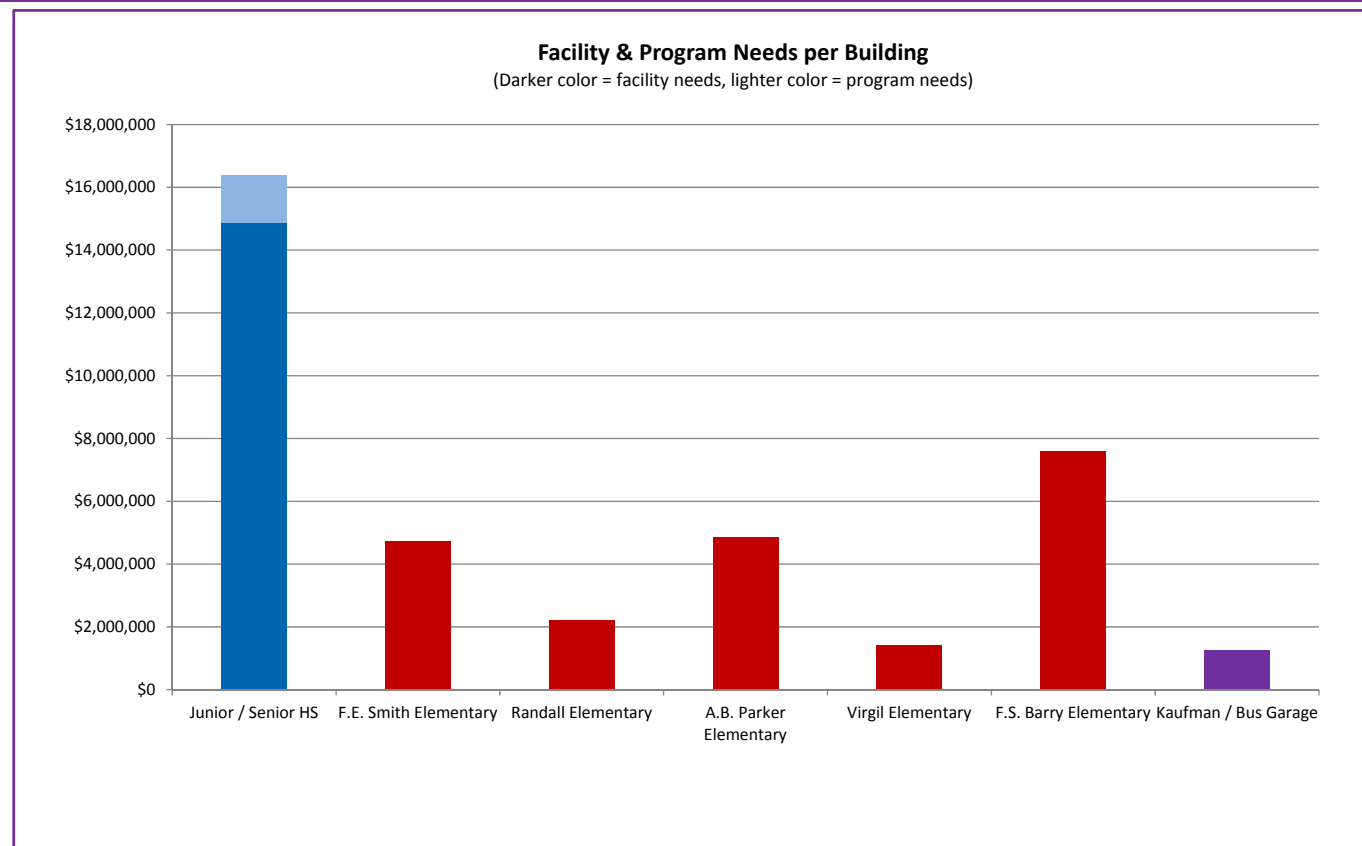
Priority 1 (0-2 Yrs):	Priority 2 (3-5 Yrs):	Priority 3 (6-10 Yrs):	Other:
Construction Costs:	\$27,720,525	\$9,108,950	\$6,432,488	\$2,173,605
Project Costs:	\$36,591,105	\$12,023,820	\$8,490,888	\$2,869,175

Facility	Priority 1	Priority 2	Priority 3	Other
Junior / Senior HS	\$11,697,895	\$3,644,938	\$3,614,850	\$213,885
F.E. Smith Elementary	\$4,160,393	\$1,800,075	\$228,908	\$18,900
Randall Elementary	\$1,118,799	\$895,500	\$799,725	\$50,820
F.S. Barry Elementary	\$4,770,081	\$996,438	\$1,033,200	\$1,800,645
A.B. Parker Elementary	\$4,278,395	\$851,875	\$365,250	\$16,380
Virgil Elementary	\$638,935	\$587,813	\$329,805	\$71,400
Kaufman / Bus Garage	\$1,056,028	\$332,313	\$60,750	\$1,575
District-Wide:	\$27,720,525	\$9,108,950	\$6,432,488	\$2,173,605

- Replacement value by facility
- Total facility needs by facility (construction cost)
- Total "other" needs by facility (construction cost)
- Program needs by facility (construction cost)
- Total District-wide needs by priority (construction cost)
- Total District-wide facility needs compared with Program needs (construction cost)
- Total District-wide Code / ADA scope, security scope, smart bond scope, and energy savings scope (construction cost)
